Troubleshooting Guide

X009 Tech Bulletin

X009-FD1Ford Sync USB/AUX Port Retention

X009-FD1 Mounting Height Adjustment

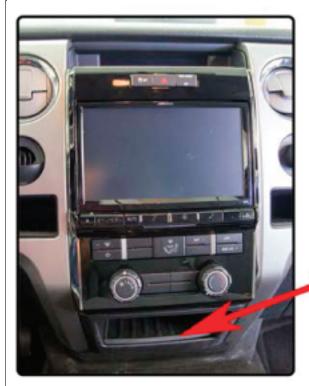
Due to the limited space in the KTX-009-FD1 radio bezel, the Ford Sync port could not be accommodated in the same location. Follow the instructions below to relocate the USB and AUX ports. (3rd party parts are required)

Trim the plastic below the pocket in the vehicles without a center console according to the 3rd party extension of your choice. If vehicle has a center console place the after market extension ports inside of it. (see 3rd party parts below)
