## **X109-WRA & X110-SLV/SRA Sound Only From Right Side Of Vehicle**

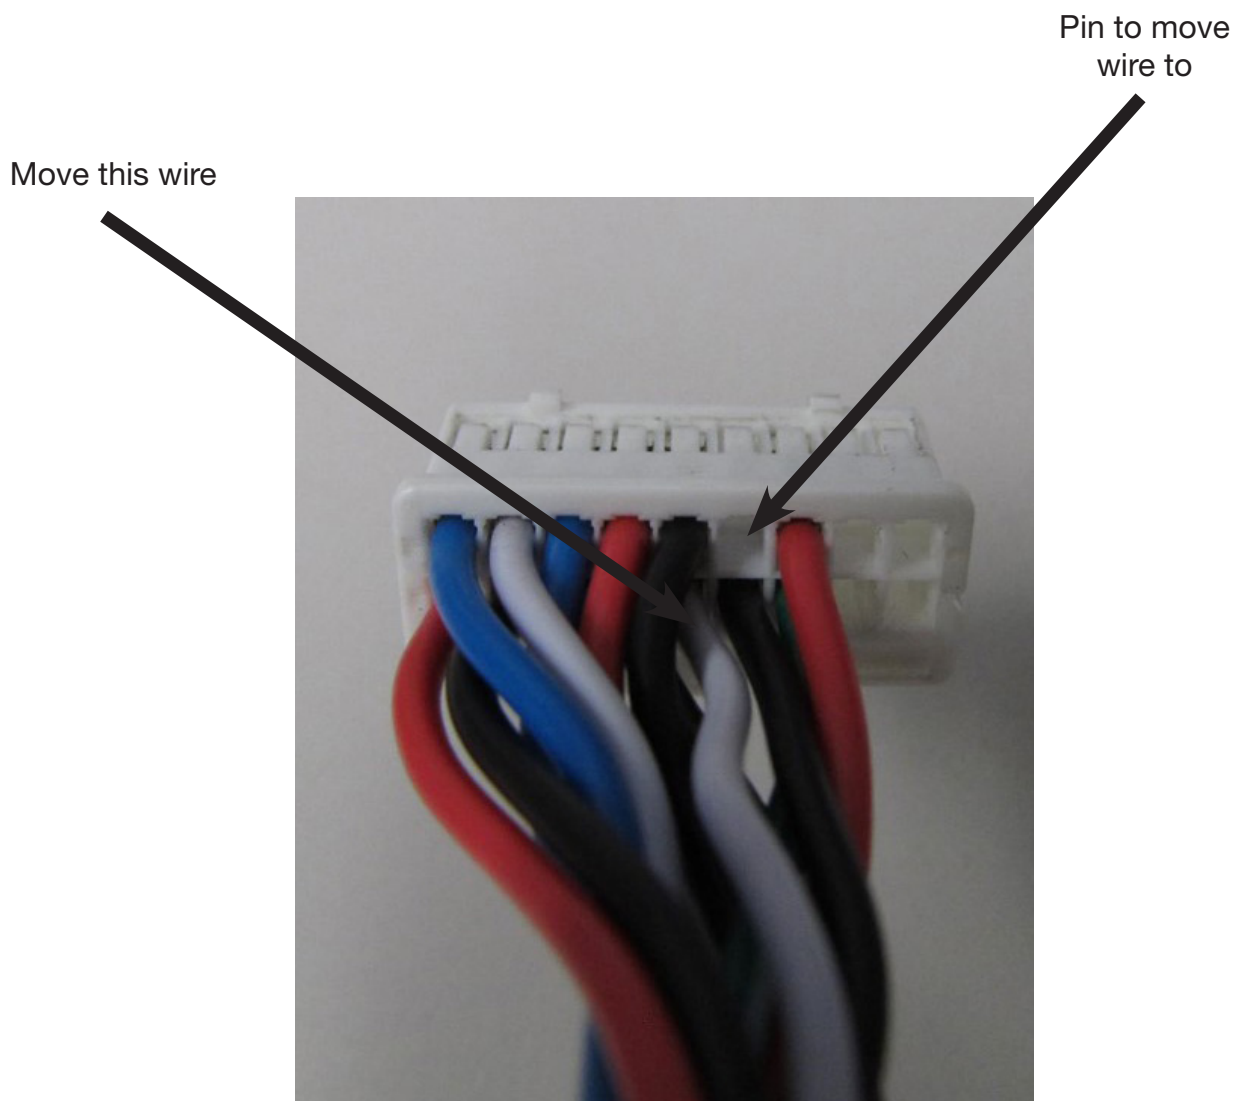
1. The CAM/AUX/DATA harness is not pinned correctly.
2. The White wire needs to be positioned in between the black wire and the red wire.
