X009-FD1 Mounting Height Adjustment

This will allow the headunit face to open in case it is hitting the bezel.

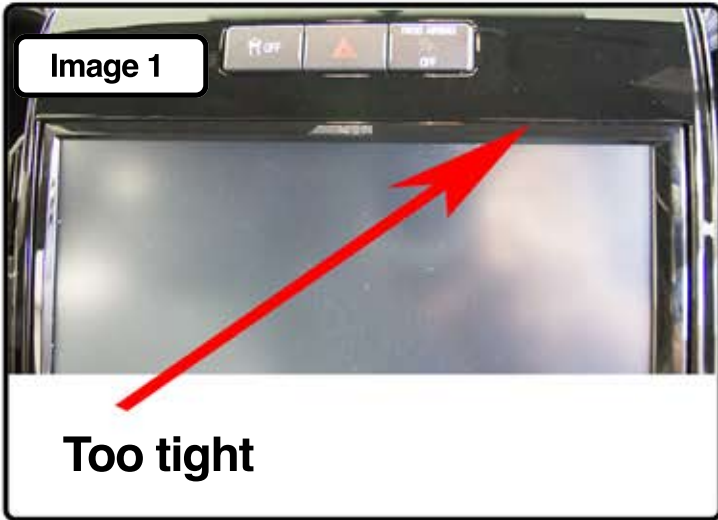
In some F-150 vehicles the X009 headunit may sit too high up against the top edge of the radio bezel preventing the face from opening. (See image 1). Use the instructions below to correct the problem. (See image 2)
