# Software Update Procedure

## iLX-W770

7-Inch Mech-Less Receiver with Apple CarPlay and Android Auto with Shallow Chassis

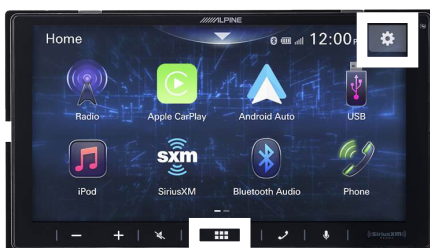
- 3-3** Go to MENU/SETUP/SYSTEM/PRODUCT INFORMATION. Note: As always to get into the settings you will need to do the parking brake sequence. Engage the parking brake, release the parking brake, and engage it a 2nd time.
